Mr. Terry Schroeder
President
MASTERDRIVE Inc.
701 Highland Avenue
Fort Atkinson, WI 53538-0157

Report No. 0804-23503

**TORSIONAL FATIGUE
OF
TAPER BUSHINGS**

July 18, 2008

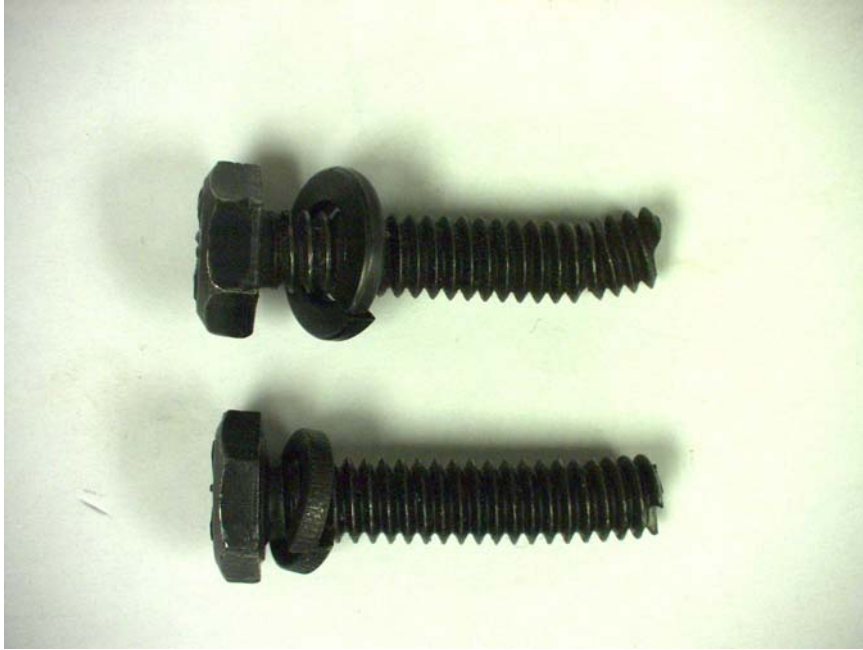
For each of the tests, the cap screws were initially tightened to 95 in-lbs with a torque wrench. In the first test, the new and normal arrangement bushings were tested at ± 810 in-lbs for 500,000 cycles and no failures were detected. The load was increased to 1,000 in-lbs, and testing continued. After only 3,280 cycles the test had shut down several times as a result of excessive deflection. The test was disassembled and inspected. The cap screws on the new arrangement bushing were bent, and failed during disassembly. It is judged that the cap screws were actually failed in the first test, but failures were not detected. The failed screws are shown in Figure 3.

In the as received hub, a 9/32 inch clearance hole was supplied. It is judged that the clearance for the cap screw in this hole allowed the screw to move back and forth during the reversing loads. This generated a failure. The hub was re-drilled with a 1/4 inch clearance hole, the hubs were re-assembled and re-tested. After 500,000 cycles at ± 810 in-lbs, no failures were detected. The torsional loads were increased and run for another 500,000 cycles. The load was increased to 1,000, 1,200 and $\pm 1,620$ in-lbs, and at each torque level, the assemblies were run for 500,000 cycles. No failures were detected upon disassembly. A list of the tests run is included as Table 1.

Fig. 3 - Overall view of failed cap screws is shown.
