Stork Technimet, Inc.

Report No. 0303-06603

BALANCE TEST OF SHEAVES

June 23, 2003

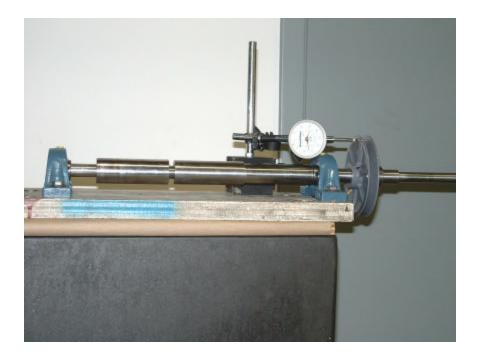
Fig. 1 - The high precision shaft and pillow blocks were mounted onto a steel plate. The dial indicator is set up to measure side to side run out.

A Grade 1070 Steel high precision shaft was mounted onto pillow blocks. The pillow blocks were bolted to a one-inch thick steel plate as shown in Figure 1. The sheaves were individually mounted onto the shaft and the set screw was lightly tightened to the shaft. In cases where the bore size was larger than the shaft diameter, a sleeve was used with the shaft. In cases where a sheave did not have a key way or precision surface, the TB Woods 1-7/16 inch spacer was bolted onto the sheave.

The amount of deflection from side to side and the change in radius for a 360° rotation was recorded and defined as the run out. For the measurements, a dial indicator with an accuracy of +/-0.001 inch was placed against the sheave. It was aligned parallel with the axis of the shaft to measure side to side run out as shown in Figure 1. It was placed perpendicular to the shaft to measure radial run out as shown in Figure 2.

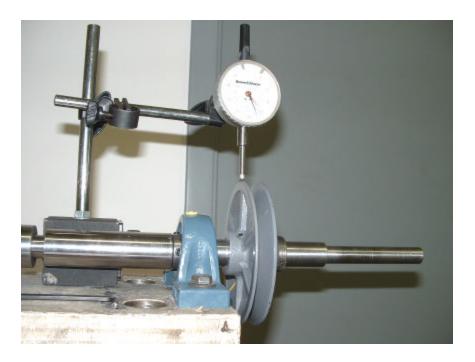
Fig. 2 - The dial indicator is set up to measure radial run out.

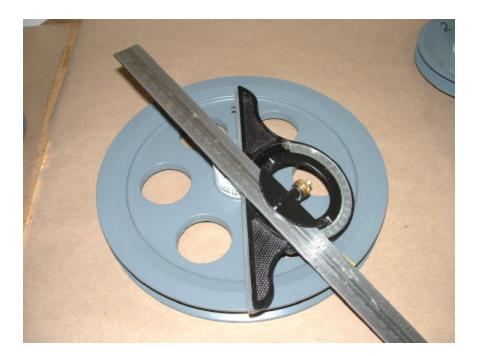
Fig. 3 - The angle of the marking with respect to the key way axis was measured.

The sheaves were dynamically measured for imbalance at Industrial Balancing. The location and magnitude of the imbalance and the test velocity were recorded and included as Table 1. Industrial Balancing marked the angular location of the imbalance onto the sheaves as shown in Figures 3 to 9 and also determined the radial location of the imbalance and measured it from the center of the sheaves. It was measured as shown in Figure 3.

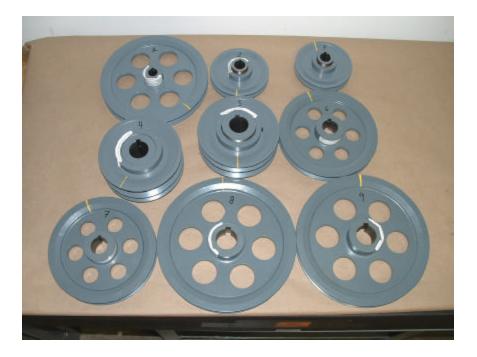
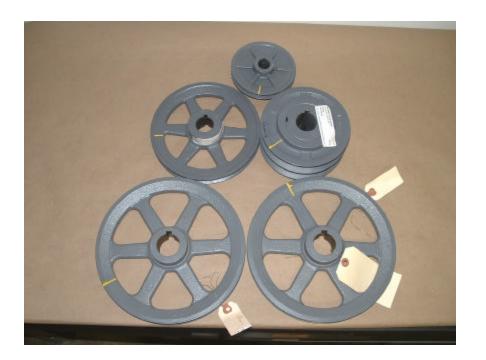
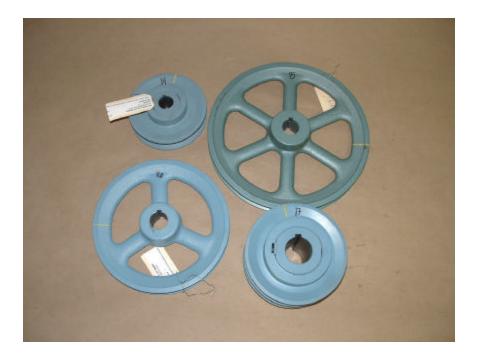
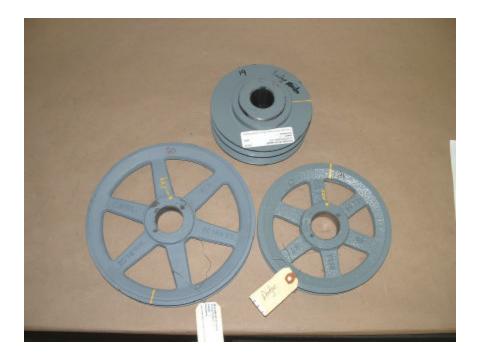
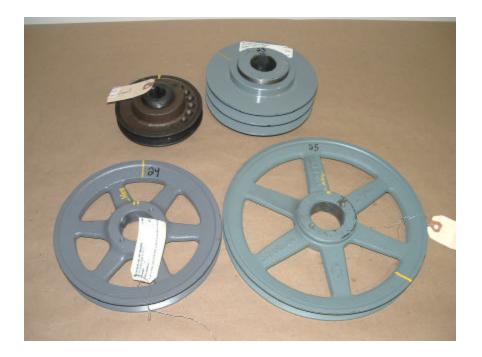
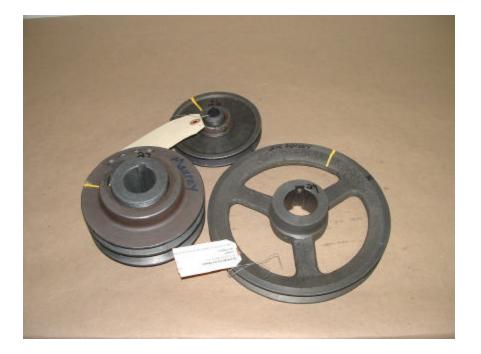
Fig. 4 - The Masterdrive sheaves are shown.

Fig. 5 - The Browning sheaves are shown.

Fig. 6 - The Maska sheaves are shown.

Fig. 7 - The Dodge sheaves are shown.

Fig. 8 - The TB Woods sheaves are shown.

Fig. 9 - The Maurey sheaves are shown.
