Report No. 0902-26828

**METALLURGICAL ANALYSIS
OF TWO
POWDER METAL HUBS**

March 10, 2009

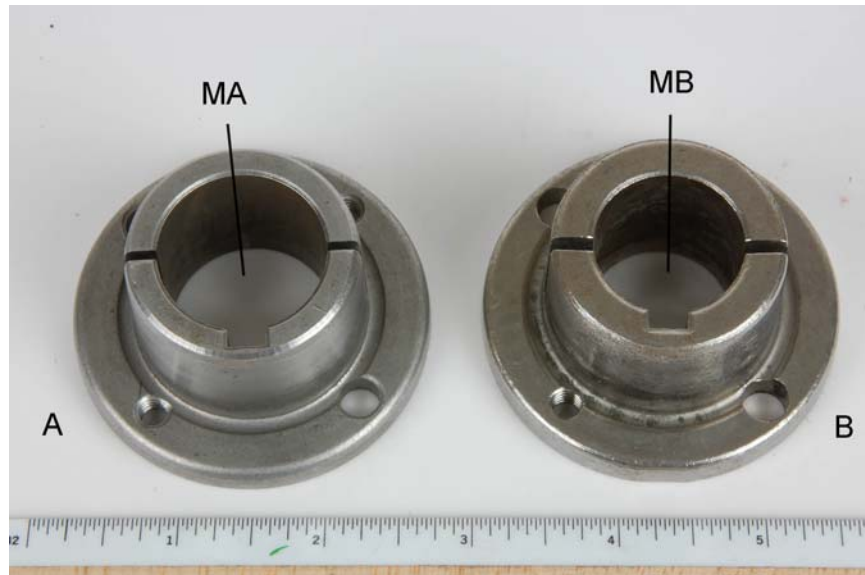
Fig. 1 - The hubs are shown as-received, where the Masterdrive hub is shown on the left and the competitive hub is shown on the right. The Masterdrive hub was identified as Sample A and the competitive hub was identified as Sample B for the purposes of this study. Sections MA and MB were selected for further analysis.

The hubs are shown as-received in Figure 1, where the powder metal hub made in China for Masterdrive is on the left and the competitor's hub is on the right. The Masterdrive hub was identified as Sample A and the competitor's hub was identified as Sample B for the purposes of this study. Sections MA and MB were selected for metallographic examination. The wall thickness of Sample A at mid-length was approximately 1/4 inch while the wall thickness at mid-length of Sample B was approximately 5/16 inch. The bottom of the hubs is shown in Figure 2. The name "Browning" was stamped on the bottom of the Sample B.

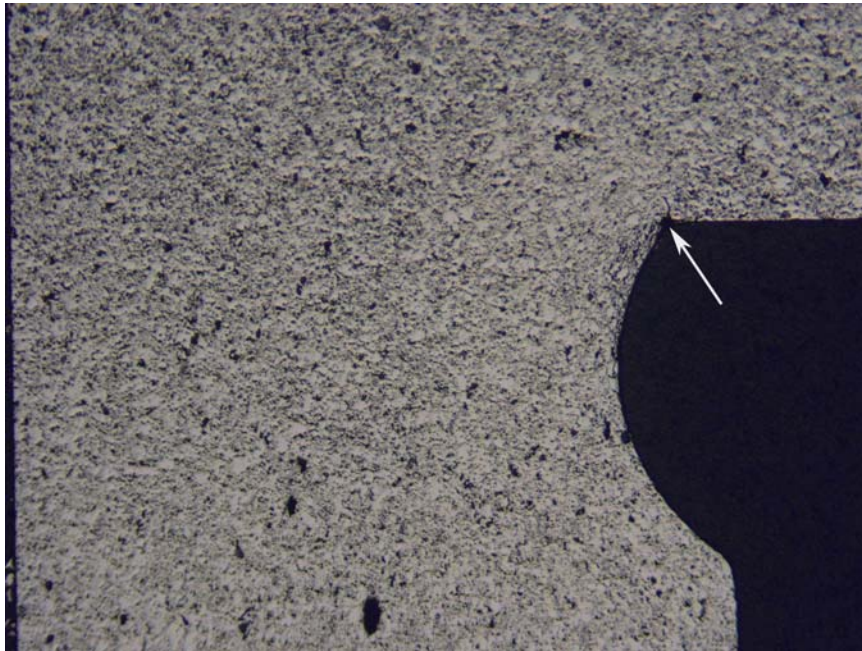
Fig. 3 - A metallographic cross section through Sample A at the area that is indicated by the black line labeled MA in Figures 1 and 2 is presented. The arrow indicates a sharp radius and crack. As polished. (15X)

Metallographic cross sections were prepared through an area of the hubs 180° away from the keyway, as indicated by the black lines labeled MA and MB in Figures 1 and 2 in order to facilitate examination of the part profile and microstructure. The profile between the flange and the body of the hub of Sample A is presented in Figure 3, where the body of the hub is oriented horizontally at the top of the image and the flange is oriented vertically at the left and center of the image. The radius between the flange and the body of the hub was very small, 0.0042 inch. A higher magnification view of the top right portion of Figure 3 is presented in Figure 4 which shows a small crack that started at the radius. In general, the smaller the radius, the higher the stress concentration will be and the more prone the part will be to fatigue cracking. The profile between the flange and the body of the hub of Sample B is presented in Figure 5, where the body of the hub is oriented horizontally at the top of the image and the flange is oriented vertically at the left and center of the image. The radius between the flange and the body of the hub in Sample B was 0.0578 inch, which is much larger in comparison to the radius in Sample A. The larger radius makes Sample B less susceptible to fatigue
